EVALUATION OF SURFACE TREATMENT TEST PITS

ELLIOT LAKE LABORATORY

NOVEMBER 1982

MINERALS RESEARCH PROGRAM
MINING RESEARCH LABORATORIES
DIVISION REPORT MRP/MRL 82-148 (TR)

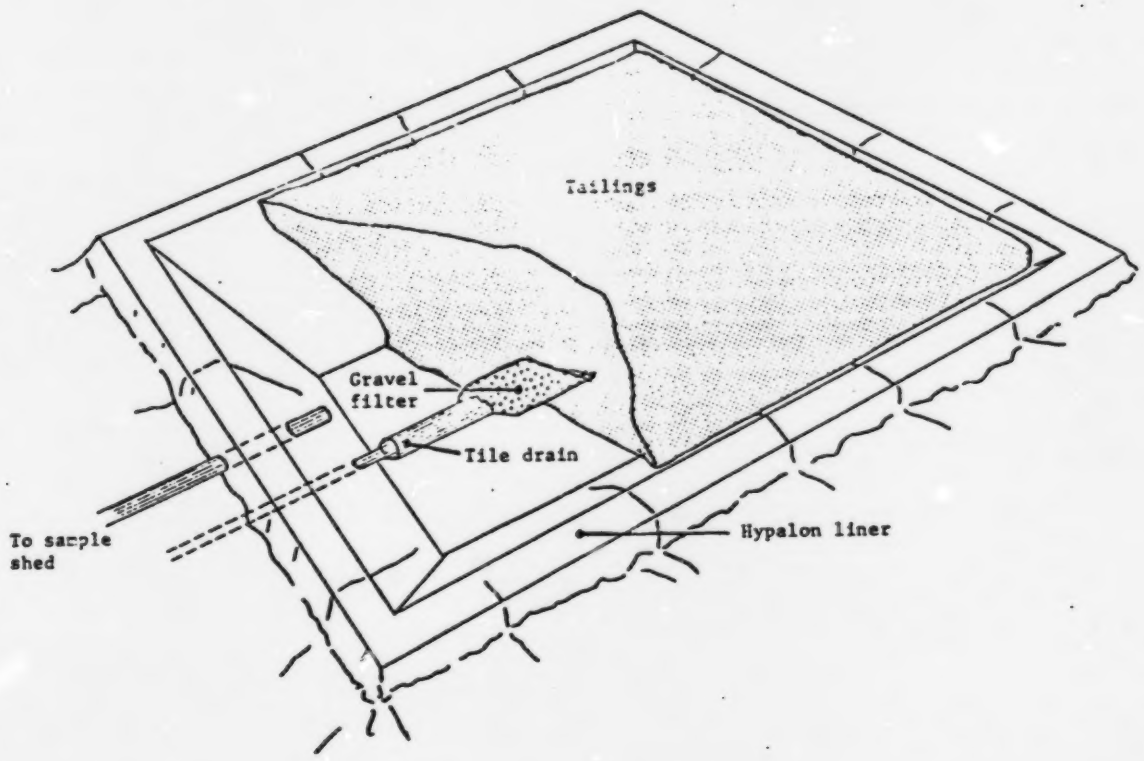
Fig. 1 - Pit construction.
